# Utility Crossing Inspection Program

Reference ID (DS\_ID): 23600

## Detailed Field Report

San Joaquin County Flood Control and Water Conservation District - (NA0017)

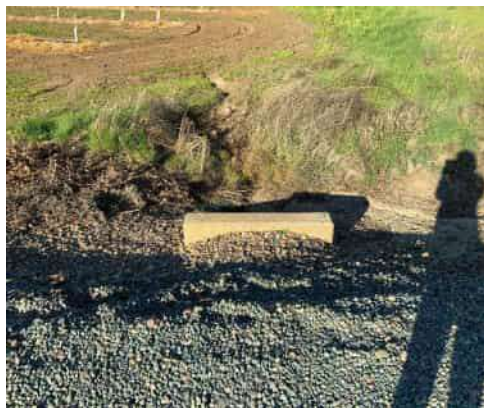
02/26/2021 (NA0017U07 LM:13.819) : LS view:  
LS headwall at toe from crown.

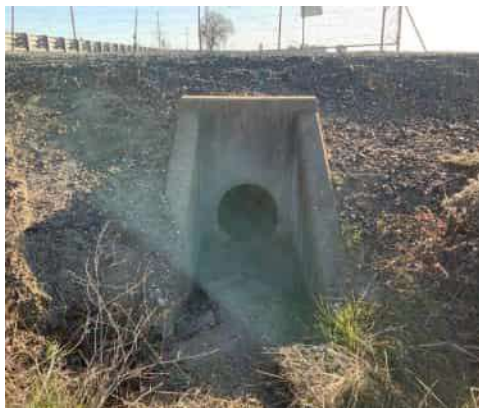
02/26/2021 (NA0017U07 LM:13.819) : LS view:  
LS headwall at toe.

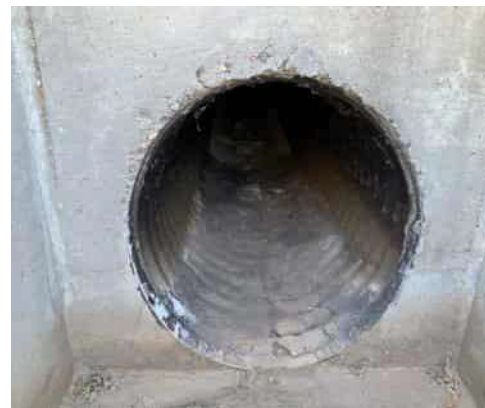
02/26/2021 (NA0017U07 LM:13.819) : LS view:  
LS pipe.

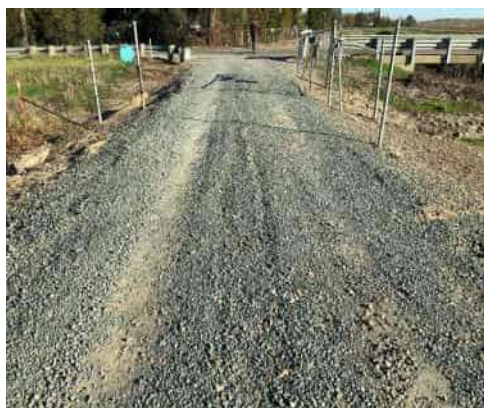
02/26/2021 (NA0017U07 LM:13.819) : Levee  
crown looking upstream.

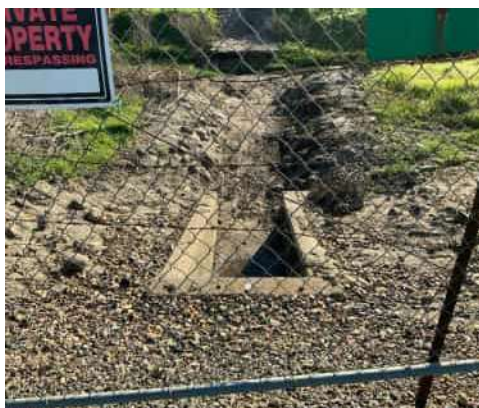
02/26/2021 (NA0017U07 LM:13.819) : WS view:  
WS headwall at toe from crown.

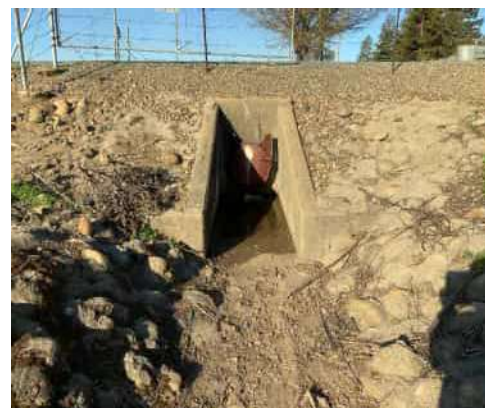
02/26/2021 (NA0017U07 LM:13.819) : WS view:  
WS headwall and flapgate at toe.

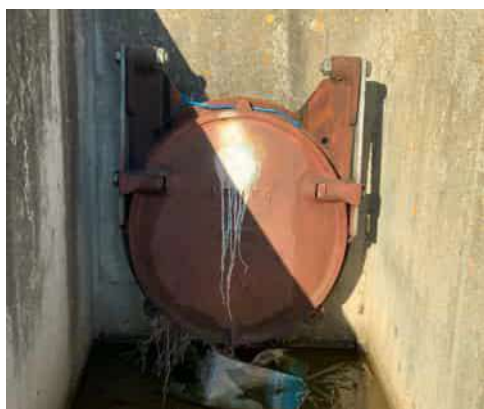
02/26/2021 (NA0017U07 LM:13.819) : WS view:  
WS flapgate.

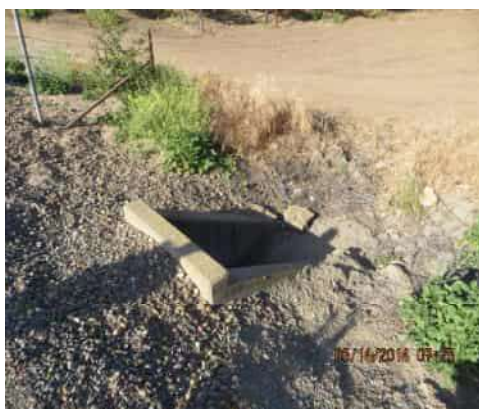
05/14/2014 (NA0017U07 LM:13.819) : Pipe and  
concrete headwall on LS toe.

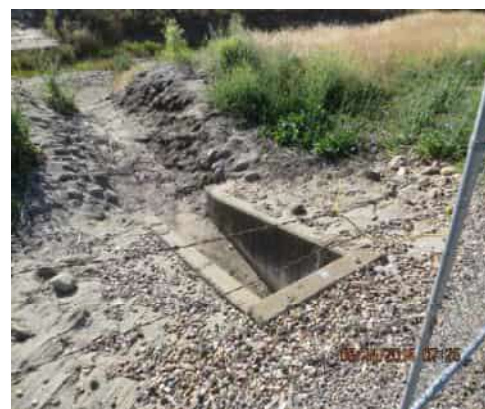
05/14/2014 (NA0017U07 LM:13.819) : Pipe, flap  
gate, cobble grouted outlet, and concrete headwall  
on the WS toe.

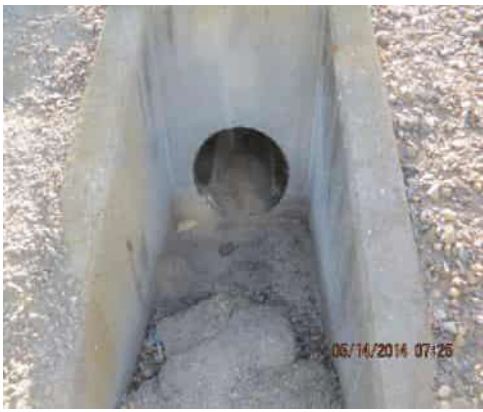
05/14/2014 (NA0017U07 LM:13.819) : Pipe and concrete headwall on LS toe.

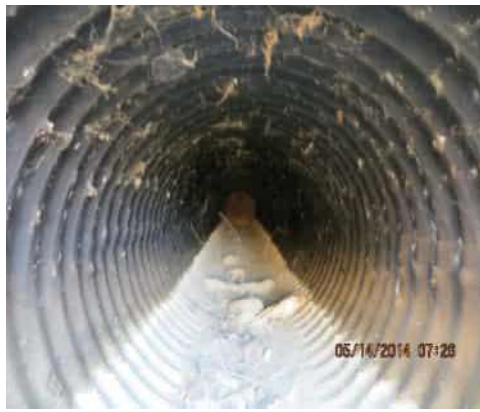
05/14/2014 (NA0017U07 LM:13.819) : Inside pipe from LS toe.

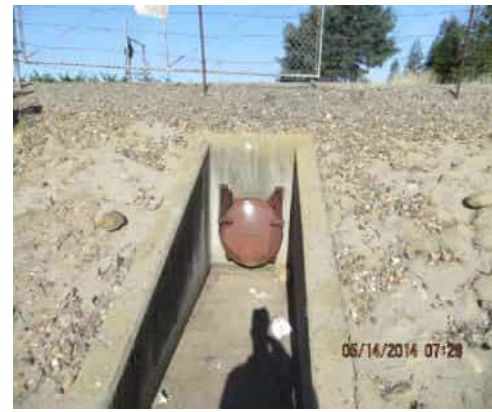
05/14/2014 (NA0017U07 LM:13.819) : Pipe, flap gate, cobble grouted outlet, and concrete headwall on the WS toe.

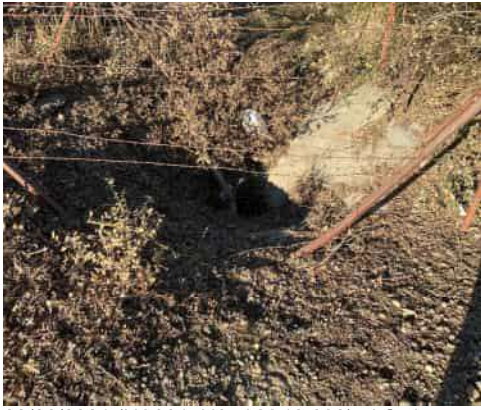
02/26/2021 (NA0017U07 LM:13.838) : LS view:  
LS toe inlet, surrounded by barbed wire.

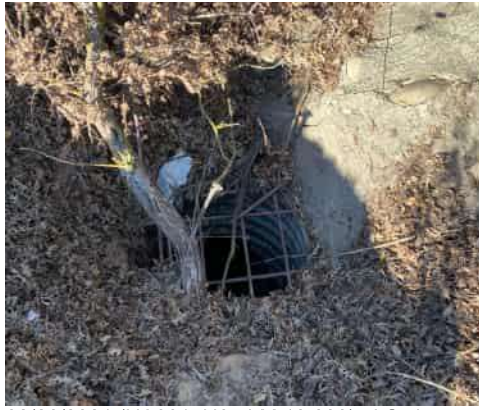
02/26/2021 (NA0017U07 LM:13.838) : LS view:  
LS toe pipe and inlet.

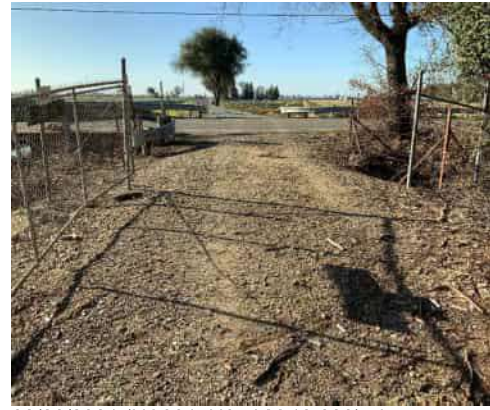
02/26/2021 (NA0017U07 LM:13.838) : Levee  
crown looking downstream.

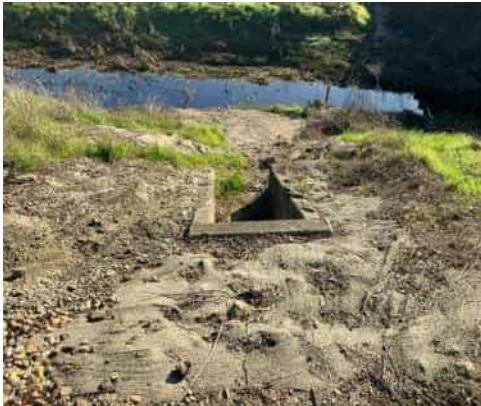
02/26/2021 (NA0017U07 LM:13.838) : WS view:  
WS headwall at toe from crown.

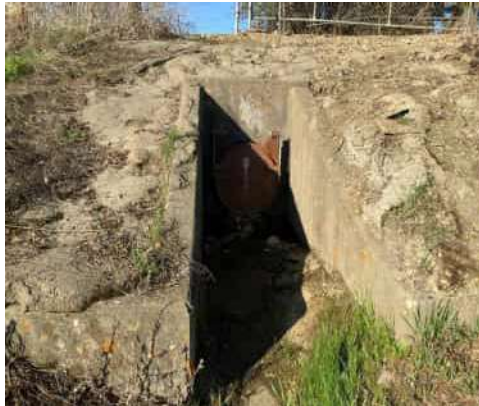
02/26/2021 (NA0017U07 LM:13.838) : WS view:  
WS headwall and flapgate at toe.

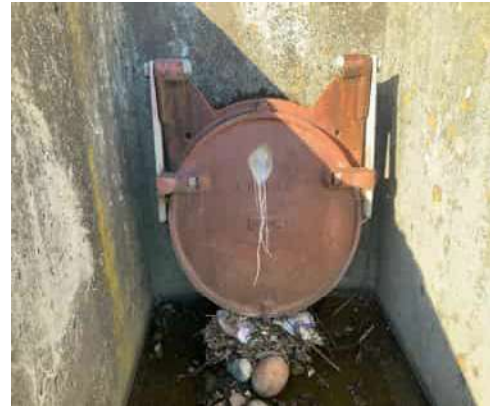
02/26/2021 (NA0017U07 LM:13.838) : WS view:  
WS flapgate.

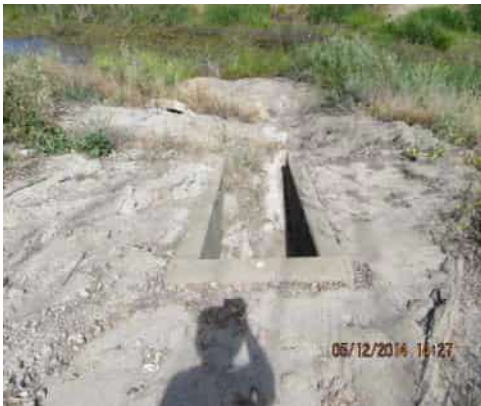
05/12/2014 (NA0017U07 LM:13.838) : Pipe,  
flapgate, and headwall on WS slope.

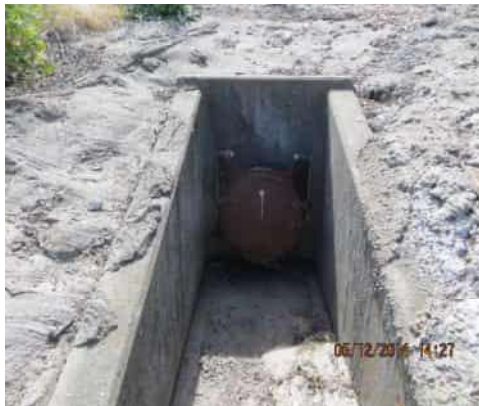
05/12/2014 (NA0017U07 LM:13.838) : Pipe,  
flapgate, and headwall on WS slope.

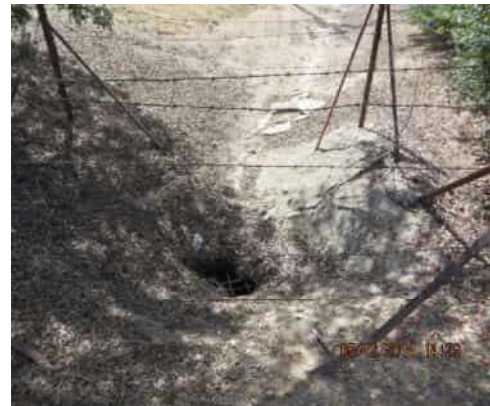
05/12/2014 (NA0017U07 LM:13.838) : Drop-inlet  
on LS toe.

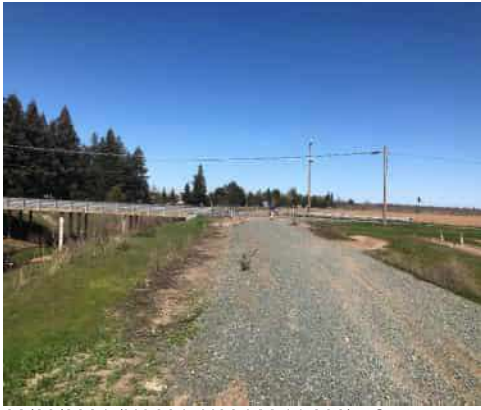
02/23/2021 (NA0017U08 LM:14.306) : Crown Overview

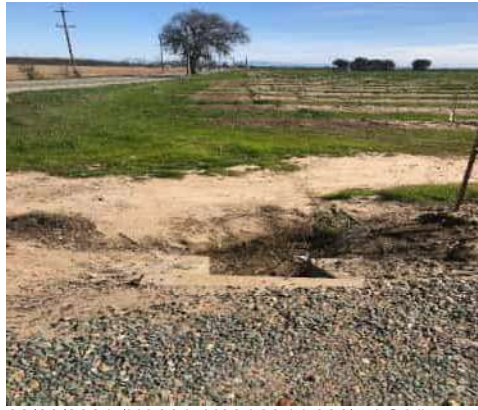
02/23/2021 (NA0017U08 LM:14.306) : LS View: Headwall on LS toe.

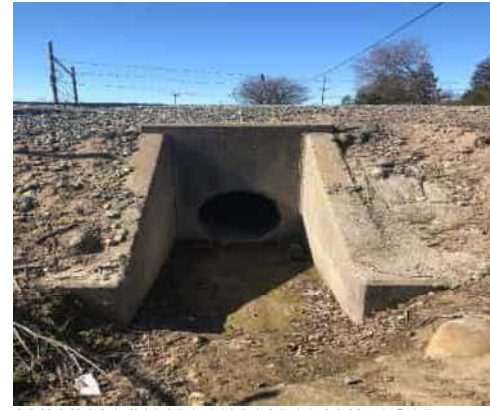
02/23/2021 (NA0017U08 LM:14.306) : LS View: Headwall at LS toe.

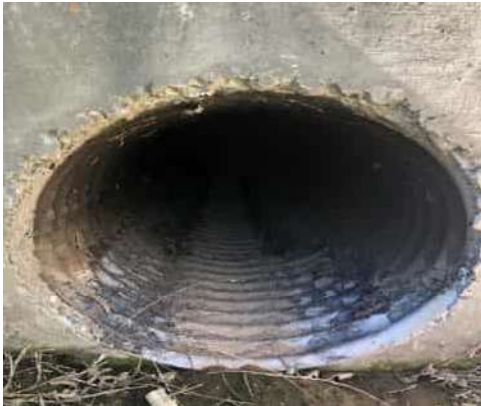
02/23/2021 (NA0017U08 LM:14.306) : LS View: Inside pipe at LS toe.

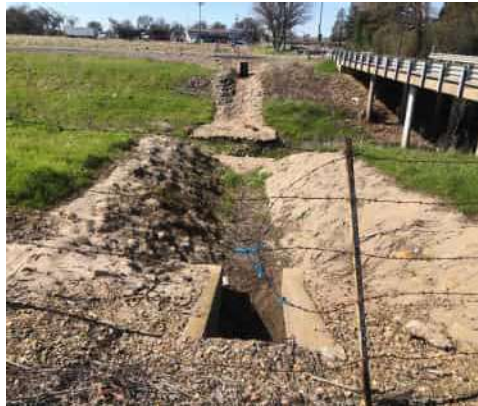
02/23/2021 (NA0017U08 LM:14.306) : WS View: Headwall on WS slope.

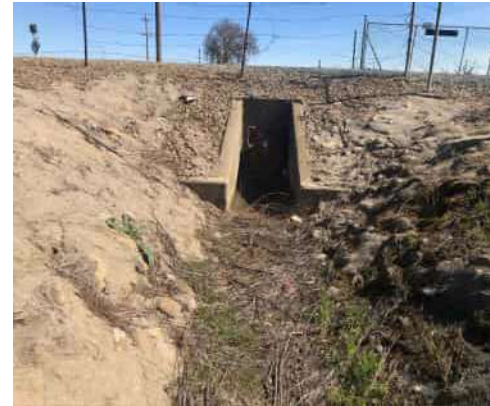
02/23/2021 (NA0017U08 LM:14.306) : WS View: Headwall and flapgate on WS slope.

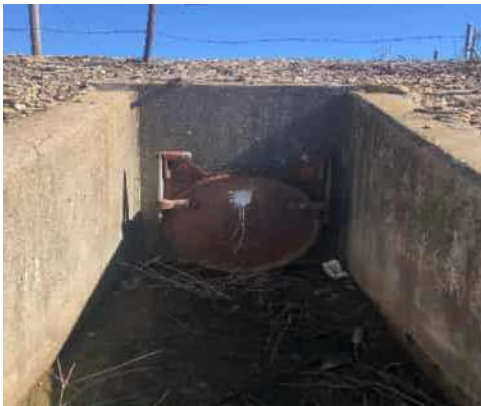
02/23/2021 (NA0017U08 LM:14.306) : WS View: Headwall and flapgate on WS slope.

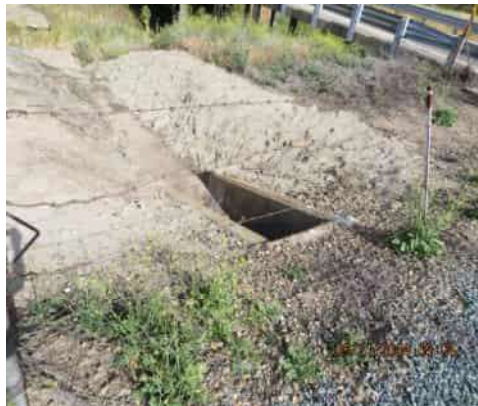
05/21/2014 (NA0017U08 LM:14.306) : Headwall, flap gate, and cobble grouted outlet on the WS slope.

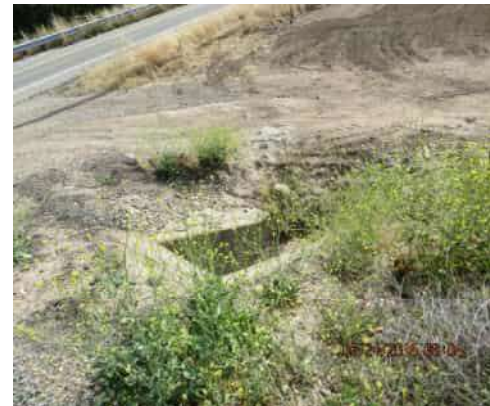
05/21/2014 (NA0017U08 LM:14.306) : Headwall on LS toe.

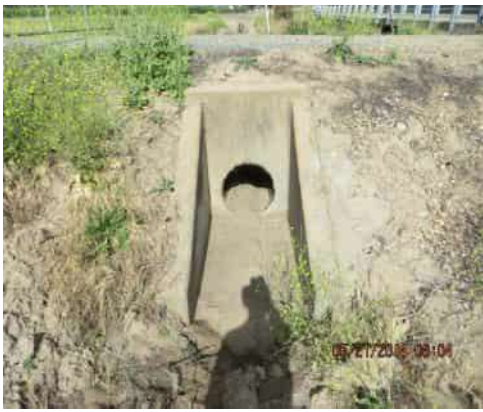
05/21/2014 (NA0017U08 LM:14.306) : Headwall on LS toe.

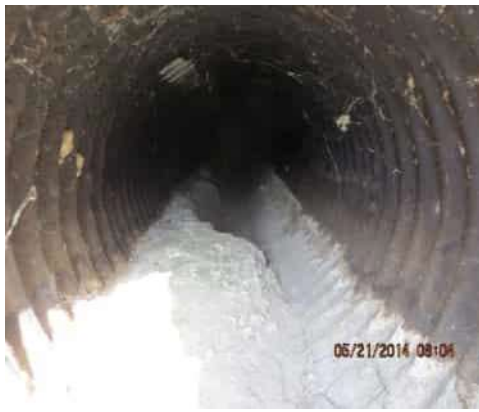
05/21/2014 Some silt buildup inside pipe. (W. Wylie - DWR DMP)

05/21/2014 (NA0017U08 LM:14.306) : Inside pipe at LS toe. Note silt buildup.

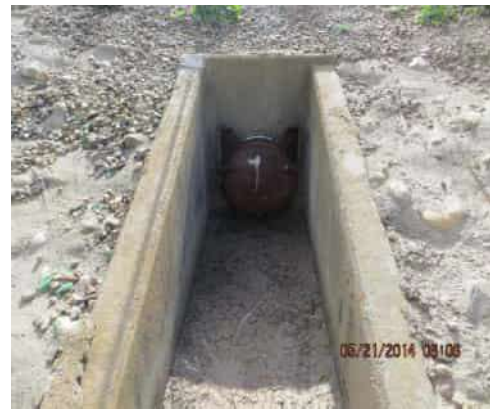
05/21/2014 (NA0017U08 LM:14.306) : Headwall and flapgate on WS slope.

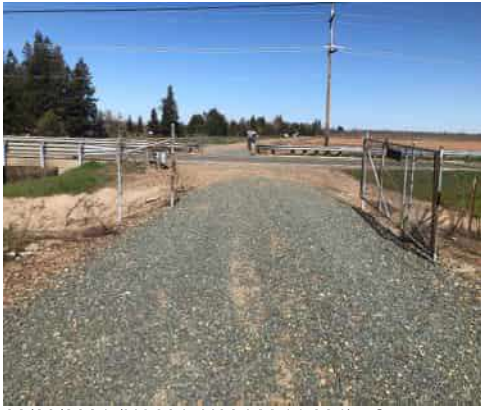
02/23/2021 (NA0017U08 LM:14.324) : Crown Overview - Utility across road.

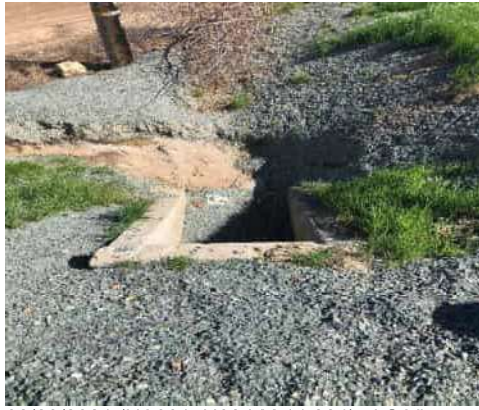
02/23/2021 (NA0017U08 LM:14.324) : LS View: Headwall at LS toe.

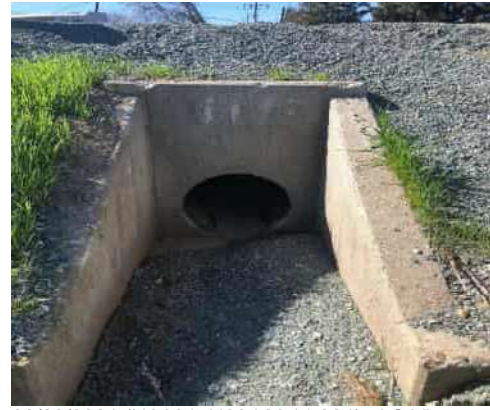
02/23/2021 (NA0017U08 LM:14.324) : LS View: Headwall at LS toe.

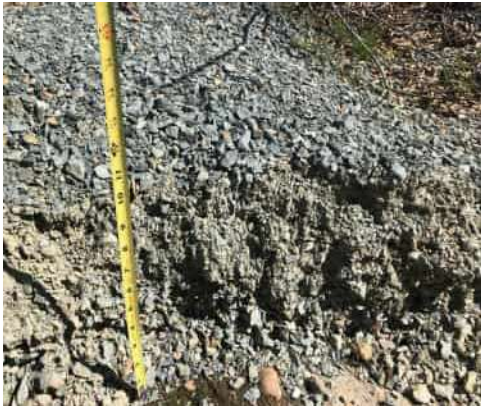
02/23/2021 (NA0017U08 LM:14.324) : LS View: Accumulation of gravel at LS toe.

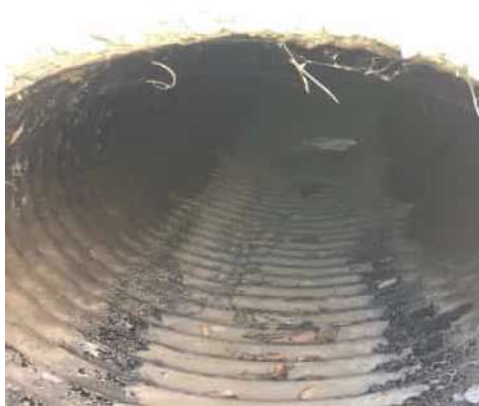
02/23/2021 (NA0017U08 LM:14.324) : LS View: Inside pipe at LS toe.

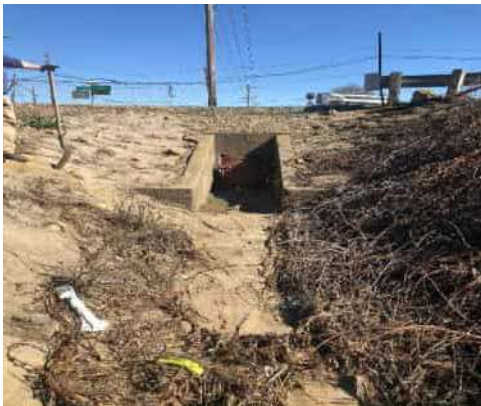
02/23/2021 (NA0017U08 LM:14.324) : WS View: Headwall and flapgate on WS slope.

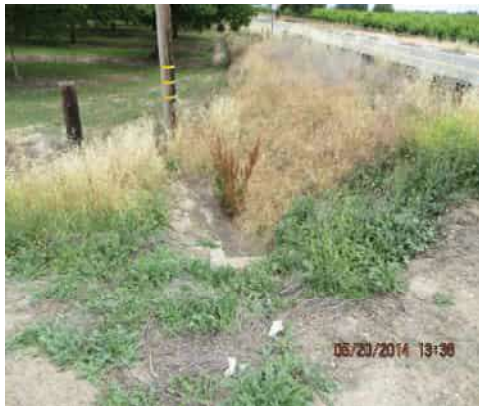
05/20/2014 (NA0017U08 LM:14.324) : Headwall on LS toe.

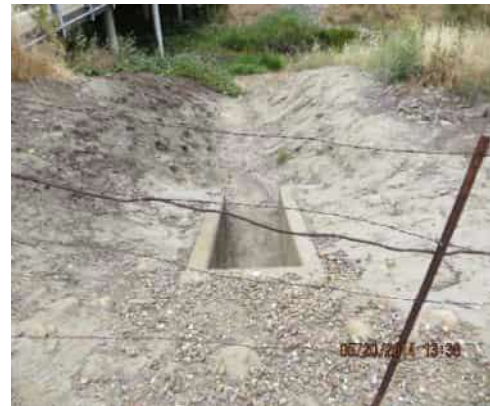
05/20/2014 (NA0017U08 LM:14.324) : Headwall and flapgate on WS toe.

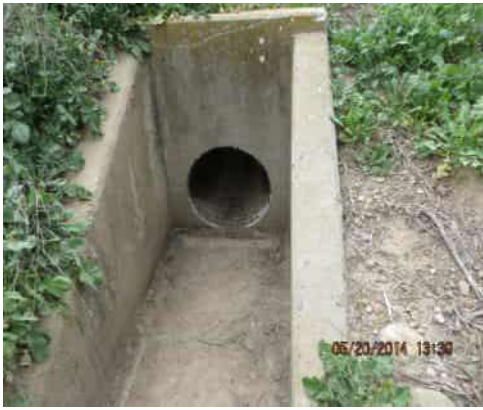
05/20/2014 (NA0017U08 LM:14.324) : Headwall at LS toe.

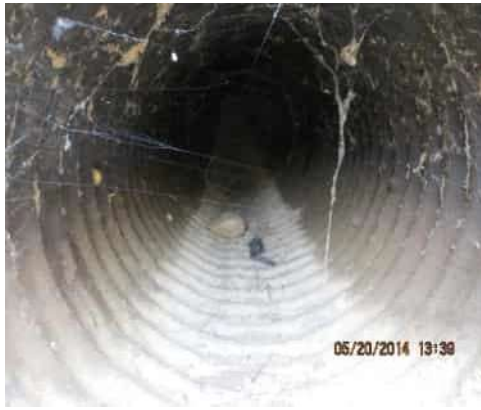
05/20/2014 (NA0017U08 LM:14.324) : Inside pipe at LS toe.

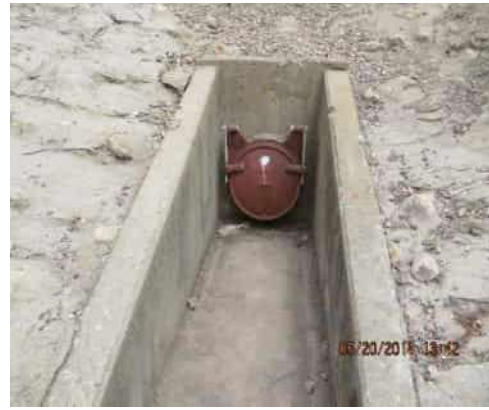
05/20/2014 (NA0017U08 LM:14.324) : headwall and flapgate on WS slope.
