REPAIR EXTENTS LOCATION PLAN
 OWNER: TULLY, GEORGE SURVEY ASSOCIATES, LLC
 PROJECT: ROCHESTER EWP 5041 (NR241800000003) SLOPE STABILIZATION
 LOCATION: 4187 VT ROUTE 100, ROCHESTER, VT
 SANBORN HEAD PROJECT NUMBER: 5342.000

SLOPE PROFILES

CONTRACT: 25017A HANES
PROJECT: ROCHESTER EMP 5041 (NR2418000X0003) SLOPE STABILIZATION
LOCATION: 4187 VT ROUTE 100, ROCHESTER, VT
SANBORN HEAD PROJECT NUMBER: 5345.000

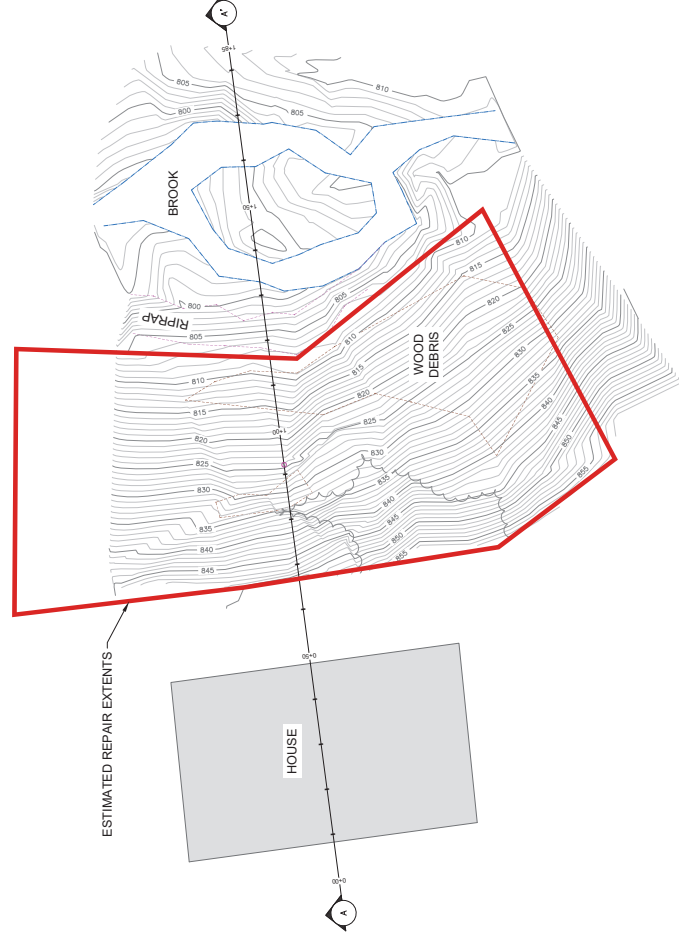
— SLOPE MEASUREMENT PROFILE LOCATION PLAN —
 THE INTENT OF THIS PLAN IS TO SHOW THE LOCATION SHOWN ON THE BROSILE SHEET.
 1. THE EXISTING CONTOUR MAP OF THIS AREA AND REGIONAL FILE 101.
 Terrain Shading which was provided to SANBORN HEAD PRODUCTIONS, SANBORN, VT
 JULY 14, 2022. SURVEY WAS PERFORMED BY TULLY, GEORGE SURVEY ASSOCIATES, LLC.

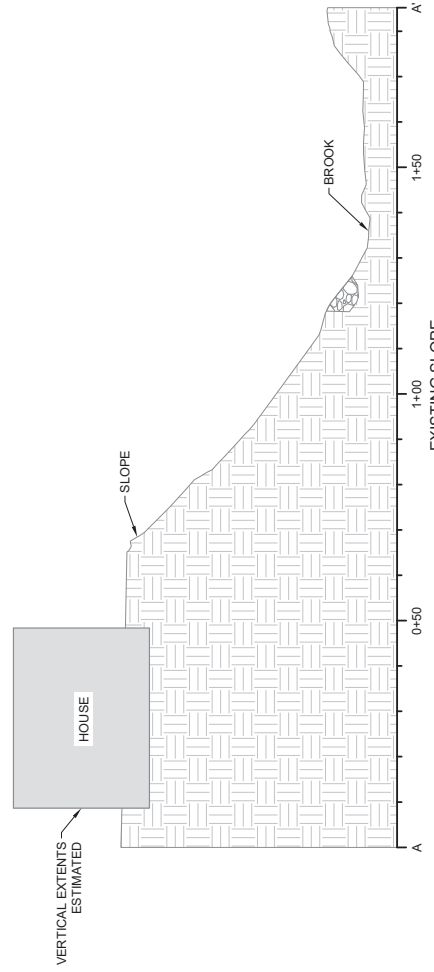
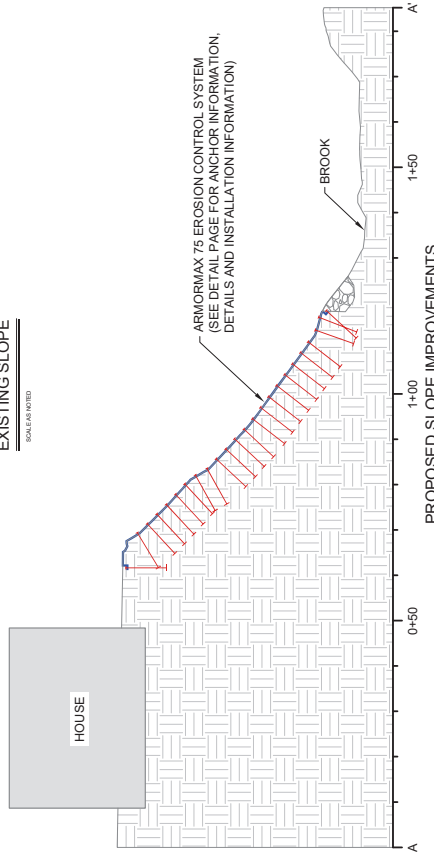
- SLOPE IMPROVEMENT PROFILE VIEWS
- THE INTENT OF THIS IS DRAW TO SHOW THE PROPOSED INSTALLATION OF ALONG THE SLOPE.
1. THE EXISTING SLOPE SURFACE IS BASED ON THE CONTACT INFORMATION PROVIDED IN FILE TITLED "ARMORMAX 75" WHICH WAS PROVIDED TO SANBORN HEAD FROM ARMORMAX CONSULTING, LLC, JULY 14, 2025. SURVEY WAS PERFORMED BY TONY GARDNER, SURVEY ASSOCIATES.
 2. REFER TO ARMORMAX 75 SLOPE INSTALLATION DETAILS PLAN SHEET AND 30' MAX INSTALLATION GUIDELINE PROFEX ARMORMAX FOR SLORES.
 3. PREPARE TO OBTAIN NECESSARY PERMITS AND OBTAIN RECOMMENDATIONS FROM THE STATE OF VERMONT.
 4. THIS REPAIR PREVENTS SURFICIAL FAILURES LIMITED TO THE UPPER FEET OF THE SLOPE FACE. THIS REPAIR DOES NOT PREVENT SLIP SURFACES THAT ARE DEEPER THAN FEET 6. DESIGN AFTER INSTALLATION OF ARMORMAX 75 TO ASSUME NO DEEP SEATED FAILURES ARE OCCURRING.
