# Limited Pre-Renovation Asbestos and Lead Paint Survey Report

**C.W. (Bill) Young, Bay Pines VA Medical Center**
**Project No. 516-CSI-134 –New 1.5T PET/CT**
**10000 Bay Pines Boulevard**
**Bay Pines, Florida 33744**

**August 27, 2025**
**Terracon Project No. H4247213, Revised**

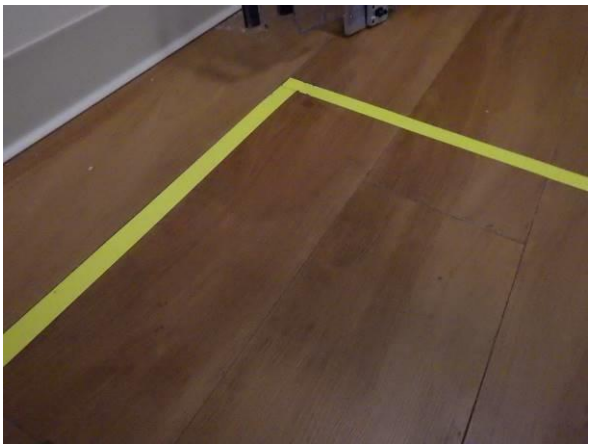
| HA# | HA DESCRIPTION | SAMPLE LOCATIONS | NESHAP / OSHA CLASSIFICATION | CONDITION | MATERIAL LOCATION | QUANTITY (SF) | ASBESTOS TYPE |
|---|---|---|---|---|---|---|---|
| CX2 | Non-asbestos 12" off white VFT and asbestos black mastic / 2C-10712 | 2C-107 2C107A | Non-Friable Cat I | Good | 2C-107 2C107A | 290 | 5% Chrysotile - Mastic |

**Photo #2** HA-CX2, 12” Off White Vinyl Floor Tile

**Non-Friable Cat I Mixed Yellow/Black Mastics**
In its current state, the noted mastics can be considered a Non-Friable, Category I ACM. As such, this material should be removed by a Florida licensed asbestos abatement contractor as an OSHA Class II work activity. In addition, The State of Florida requires any concrete waste (CMU, Slab, etc.) to be free of any ACM material (paint, mastics, etc.) prior to disposal or recycling.

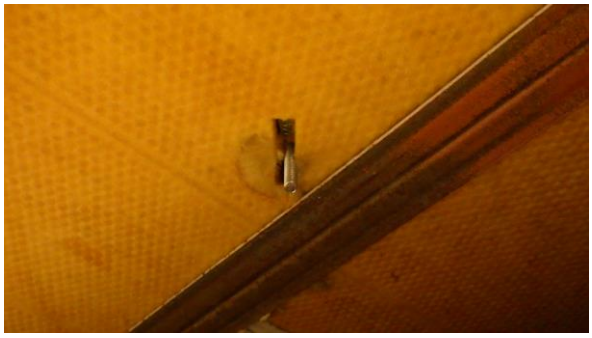
**Photo #29** HA-CX29, Fiberglass Insulation Panel, Above Ceiling

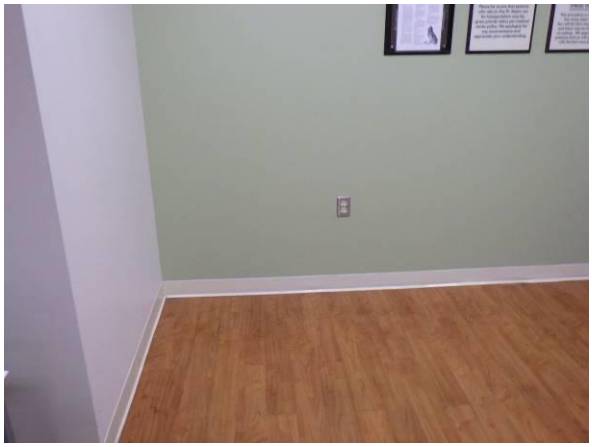
**Photo #35** Paint CP3, Wall - Teal

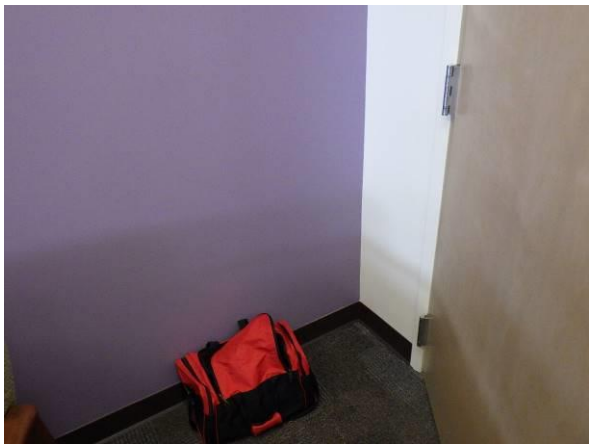
**Photo #39** Paint CP7, Door Frame - White

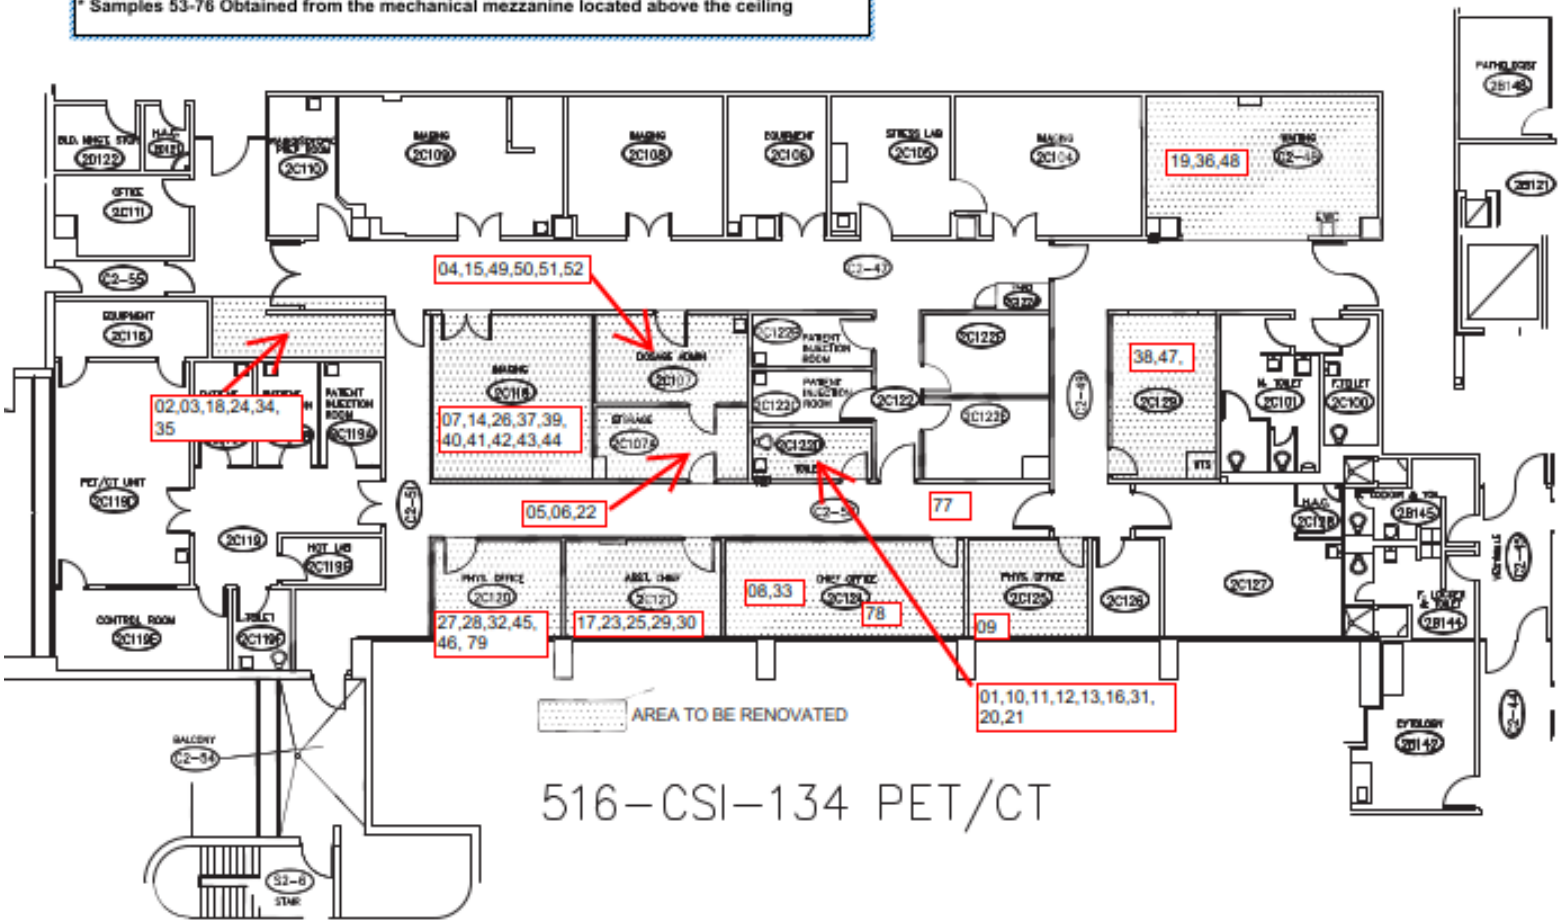
# ASBESTOS SAMPLE LOCATIONS

* Samples 53-76 Obtained from the mechanical mezzanine located above the ceiling

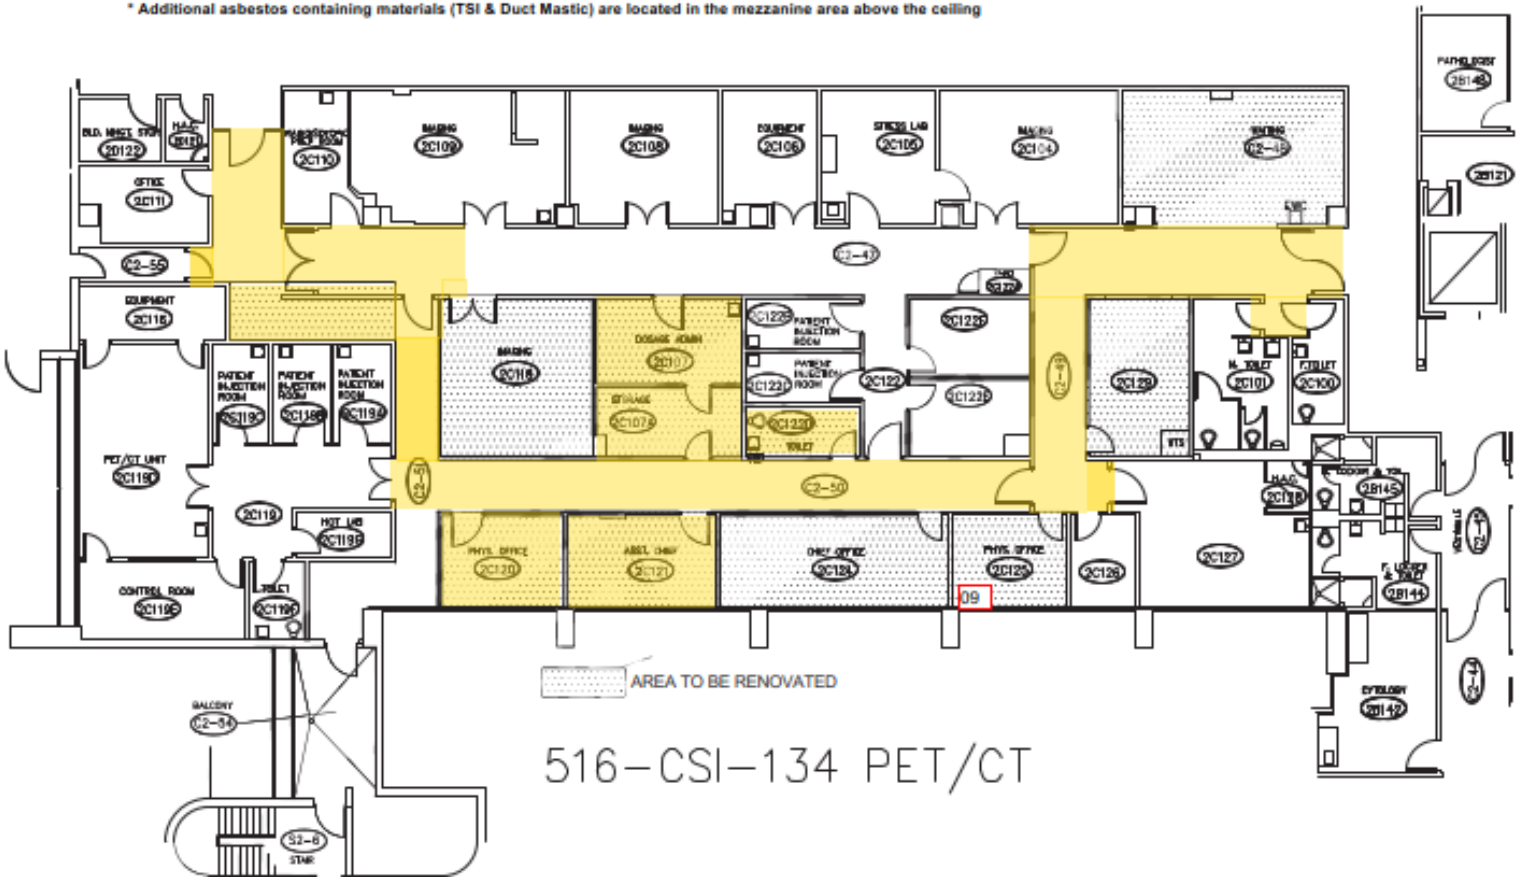
Areas found to contain asbestos flooring materials

* Additional asbestos containing materials (TSI & Duct Mastic) are located in the mezzanine area above the ceiling
