Initial Annual Fire & Smoke Door Inspection

Inspection No.:	SLS484561
Code Edition:	NFPA 80 - 2010 for Healthcare
Inspection Initiated:	August 26 2024

Initial Annual Fire & Smoke Door Inspection Summary

Name	Manchester Va	**Contact**	Faletti, Alex
Address	718 Smyth Road	**Contact #**	(801) 201-8438
City, State Zip	Manchester, NH 03104	**Inspection Dates**	8/26/2024 To 9/18/2024

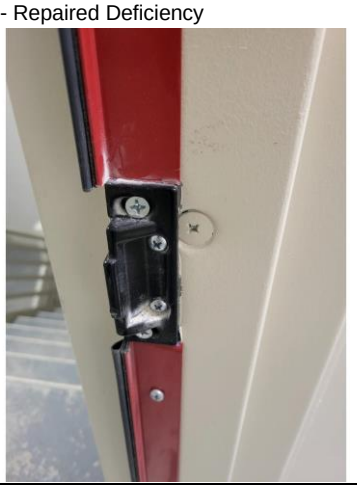
FC4 - Repaired Deficiency

Criteria	Failed Notes	General Notes	Components	Repaired	Compliant Repaired
FC4	Strike plate missing fastener		Hardware	Yes	Yes

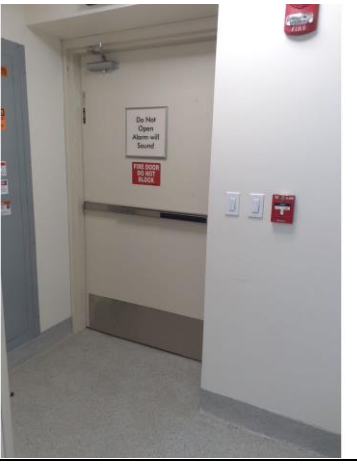
FC4 - Deficiency

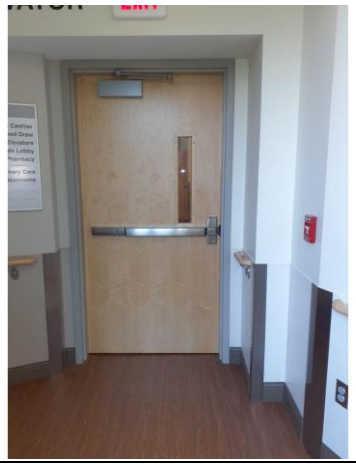
FC4 - Deficiency

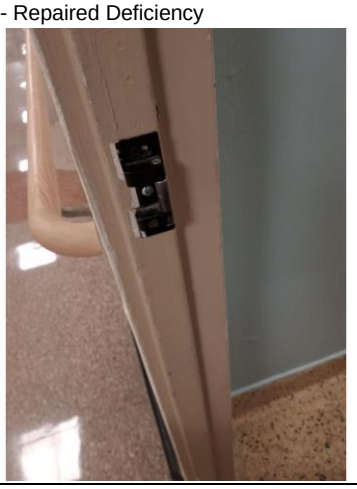
FC4 - Repaired Deficiency

Criteria	Failed Notes	General Notes	Components	Repaired	Compliant Repaired
FC4	Strike plate missing fastener		Frame	Yes	Yes

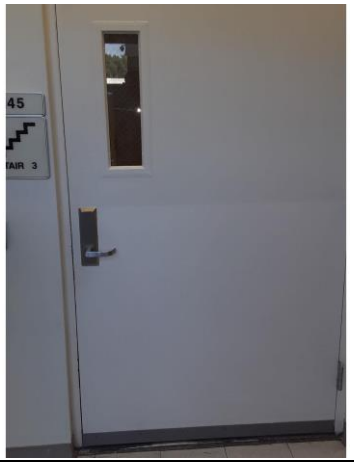
FC6 - Deficiency

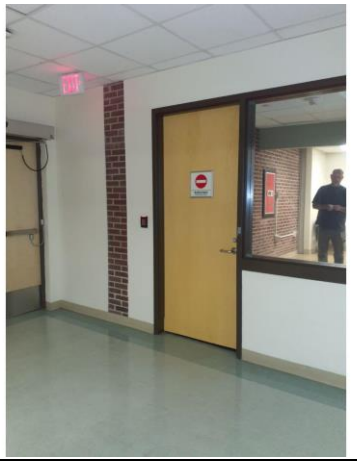
Criteria	Failed Notes	General Notes	Components	Repaired	Compliant Repaired
FC4	Missing closer		Hardware	No	No

FC4 - Deficiency

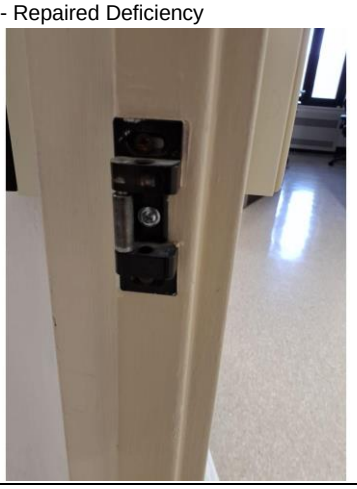
FC4 - Repaired Deficiency

Criteria	Failed Notes	General Notes	Components	Repaired	Compliant Repaired
FC4	Strike plate missing fastener		Frame	Yes	Yes

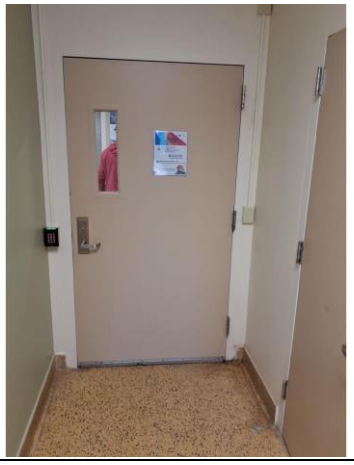
FC4 - Deficiency

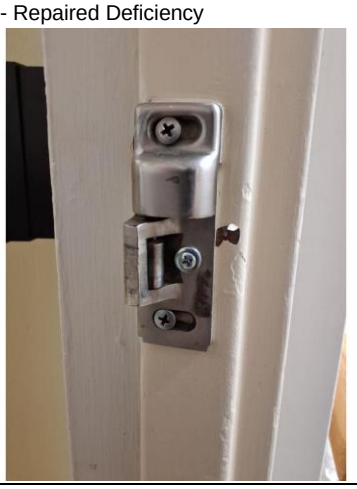
FC4 - Repaired Deficiency

Criteria	Failed Notes	General Notes	Components	Repaired	Compliant Repaired
FC4	Strike plate missing fastener		Frame	Yes	Yes

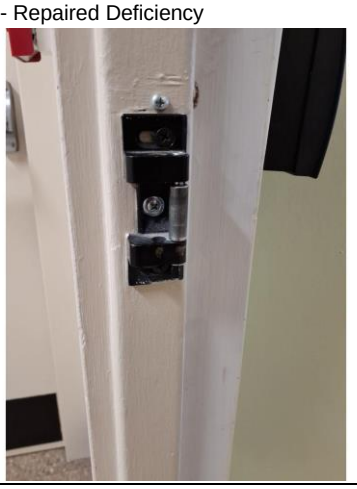
FC4 - Repaired Deficiency

Criteria	Failed Notes	General Notes	Components	Repaired	Compliant Repaired
FC4	Strike plate missing fastener		Frame	Yes	Yes

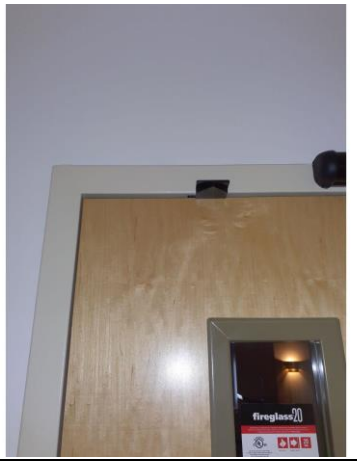
Building: DVA-1 Floor: 2 Opening: 0149

Barcode Door Type	Fire / Smoke Door Material	P/F Door Size	Area Frame Material	Inspector Barrier Type	Date Priority
FC5 - Deficiency

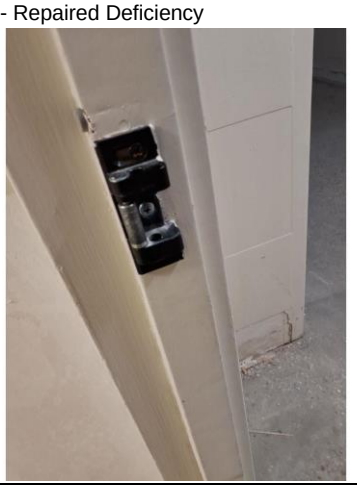
FC4 - Repaired Deficiency

Criteria	Failed Notes	General Notes	Components	Repaired	Compliant Repaired
FC4	Strike plate missing fastener		Frame	Yes	Yes

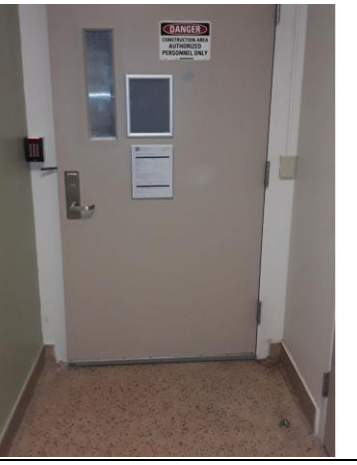
FC4 - Deficiency

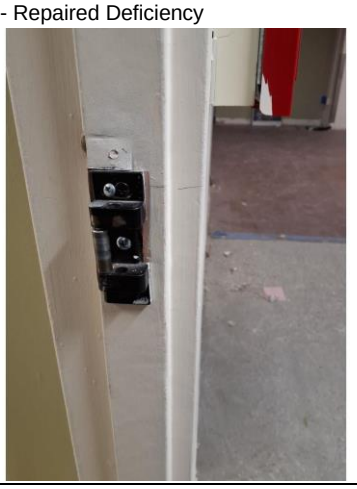
FC4 - Repaired Deficiency

Criteria	Failed Notes	General Notes	Components	Repaired	Compliant Repaired
FC4	Strike plate missing fastener		Frame	Yes	Yes

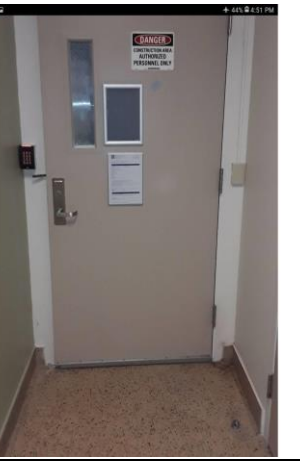
FC4 - Deficiency

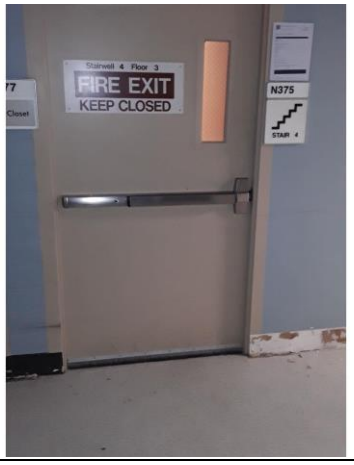
FC4 - Deficiency

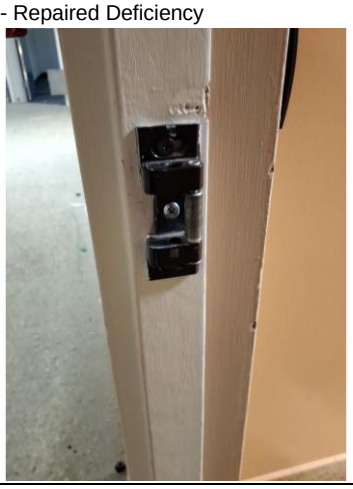
FC4 - Repaired Deficiency

Criteria	Failed Notes	General Notes	Components	Repaired	Compliant Repaired
FC4	Strike plate missing fastener		Frame	Yes	Yes

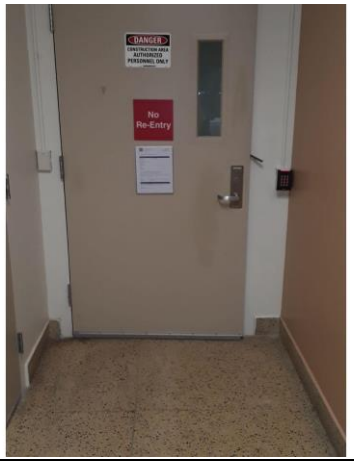
FC4 - Deficiency

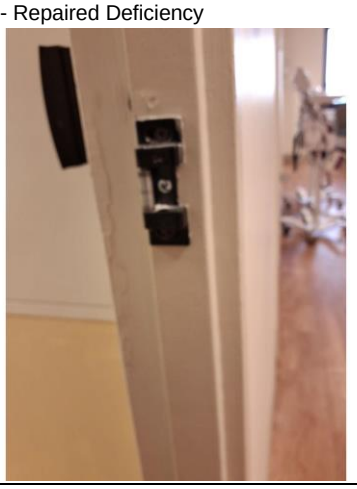
FC4 - Repaired Deficiency

Criteria	Failed Notes	General Notes	Components	Repaired	Compliant Repaired
FC4	Strike plate missing fastener		Frame	Yes	Yes

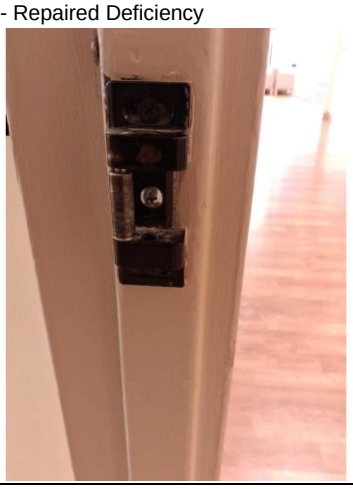
FC4 - Repaired Deficiency

Criteria	Failed Notes	General Notes	Components	Repaired	Compliant Repaired
FC4	Strike plate missing fastener		Frame	Yes	Yes

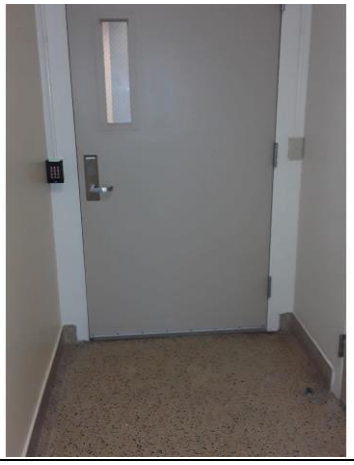
FC4 - Deficiency

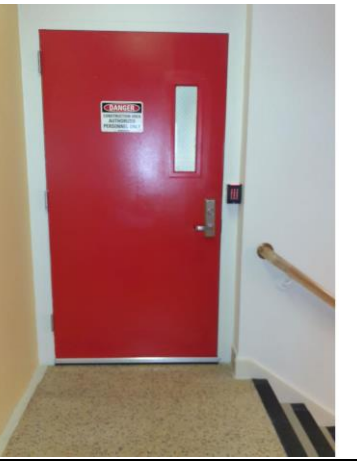
FC4 - Deficiency

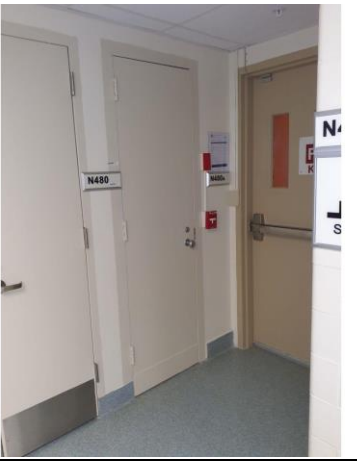
FC8 - Repaired Deficiency

Criteria	Failed Notes	General Notes	Components	Repaired	Compliant Repaired
FC8	Latch obstructed (tape or other means)		Hardware	Yes	Yes

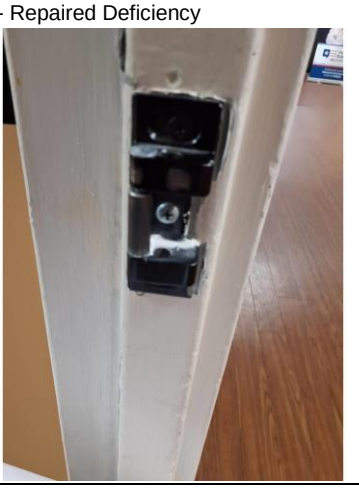
FC4 - Repaired Deficiency

Criteria	Failed Notes	General Notes	Components	Repaired	Compliant Repaired
FC4	Strike plate missing fastener		Frame	Yes	Yes
FC5	WD/PLAM strike edge clearance > 1/8" Bottom clearance for HM and WD/PLAM > 3/4"		Strike Edge	Yes	Yes

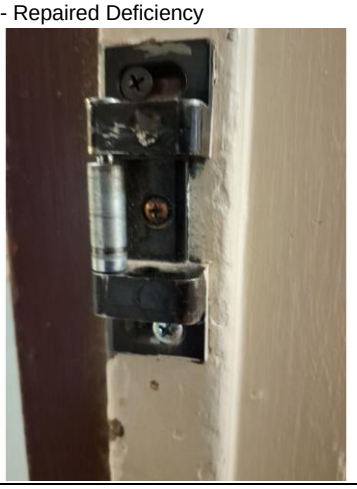
FC4 - Repaired Deficiency

Criteria	Failed Notes	General Notes	Components	Repaired	Compliant Repaired
FC4	Strike plate missing fastener		Frame	Yes	Yes

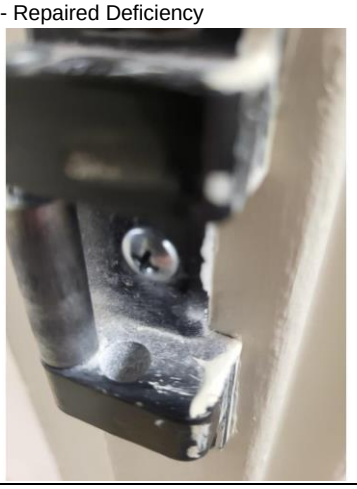
FC4 - Repaired Deficiency

Criteria	Failed Notes	General Notes	Components	Repaired	Compliant Repaired
FC4	Strike plate missing fastener		Hardware	Yes	Yes

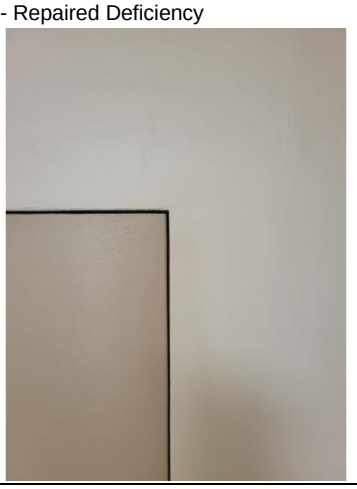
FC5 - Repaired Deficiency

Criteria	Failed Notes	General Notes	Components	Repaired	Compliant Repaired
FC5	HM top edge clearance > 3/16"		Top	Yes	Yes

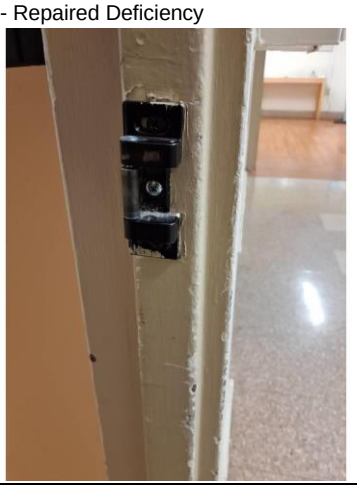
FC4 - Repaired Deficiency

Criteria	Failed Notes	General Notes	Components	Repaired	Compliant Repaired
FC4	Strike plate missing fastener		Frame	Yes	Yes

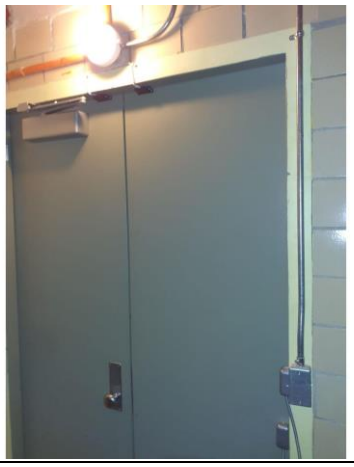
FC1 - Repaired Deficiency

Criteria	Failed Notes	General Notes	Components	Repaired	Compliant Repaired
FC1	Missing silencer / mute		Frame	Yes	Yes

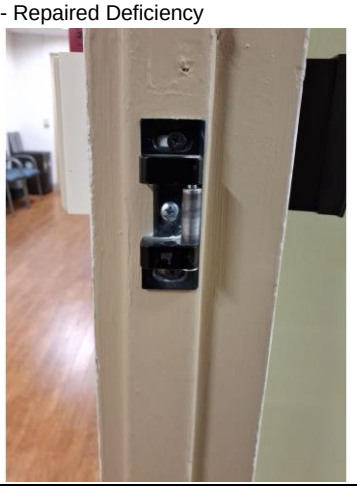
FC4 - Repaired Deficiency

Criteria	Failed Notes	General Notes	Components	Repaired	Compliant Repaired
FC4	Strike plate missing fastener		Frame	Yes	Yes
FC12	Signage > 5%		Size	No	No

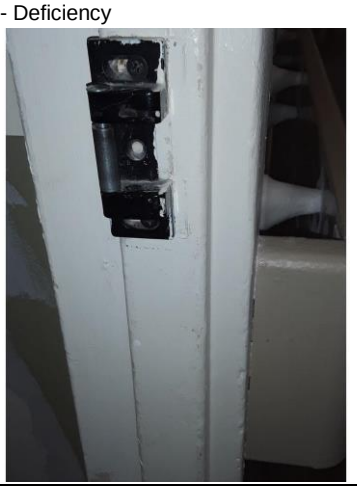
FC4 - Deficiency

Criteria	Failed Notes	General Notes	Components	Repaired	Compliant Repaired
FC4	Strike plate missing fastener		Frame	Yes	Yes

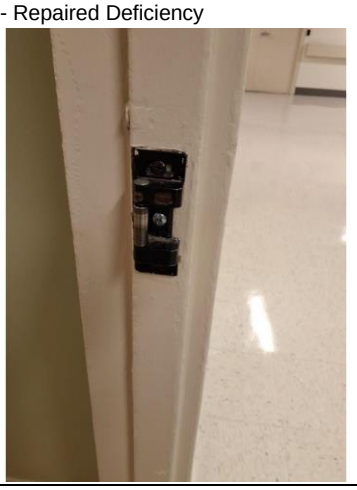
FC4 - Repaired Deficiency

Criteria	Failed Notes	General Notes	Components	Repaired	Compliant Repaired
FC1	Missing hardware leaving hole in frame / door		Frame	No	No
FC4	Strike plate missing fastener		Hardware	Yes	Yes
FC5	HM top edge clearance > 3/16"		Top	No	No

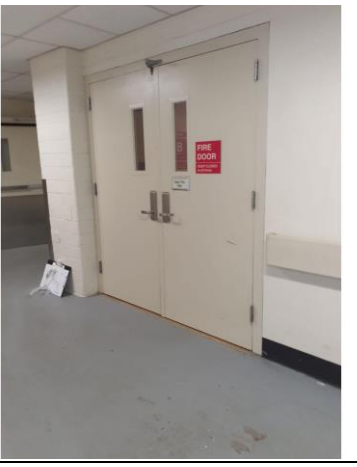
Criteria	Failed Notes	General Notes	Components	Repaired	Compliant Repaired
FC8	Door rubs or binds preventing latch engagement		Hardware	No	No

FC8 - Deficiency

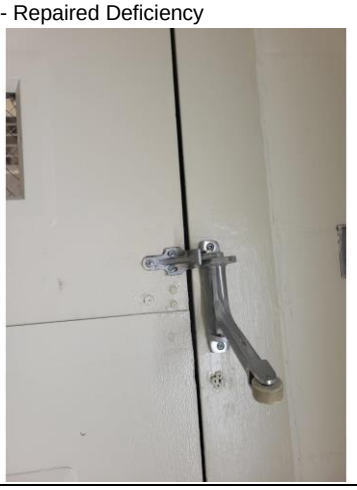
Criteria	Failed Notes	General Notes	Components	Repaired	Compliant Repaired
FC7	Coordinator is not damaged but not working properly		Hardware	Yes	Yes

FC7 - Repaired Deficiency

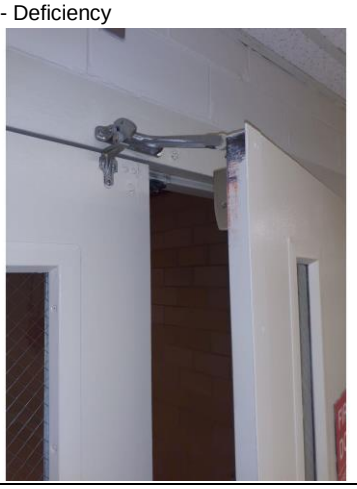
FC7 - Deficiency

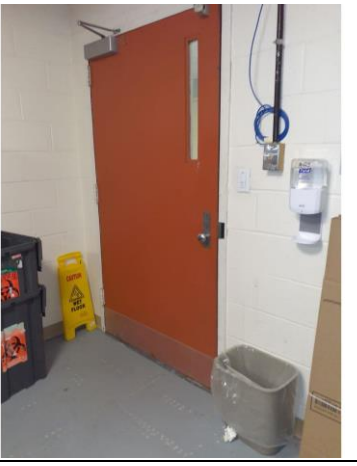
Criteria	Failed Notes	General Notes	Components	Repaired	Compliant Repaired
FC10	Protection plate on door made of combustible material (e.g. masonite, plywood, plexiglass)		Door	No	No

FC10 - Deficiency

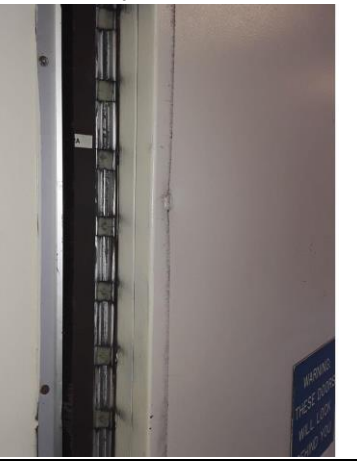
Criteria	Failed Notes	General Notes	Components	Repaired	Compliant Repaired
FC5	Bottom clearance for HM and WD/PLAM > 3/4"		Bottom	No	No
FC13.D	Missing / illegible door label (double-check top of door)		Door	No	No
FC13.F	Missing / illegible frame label		Frame	No	No

FC13.D - Deficiency

FC13.F - Deficiency

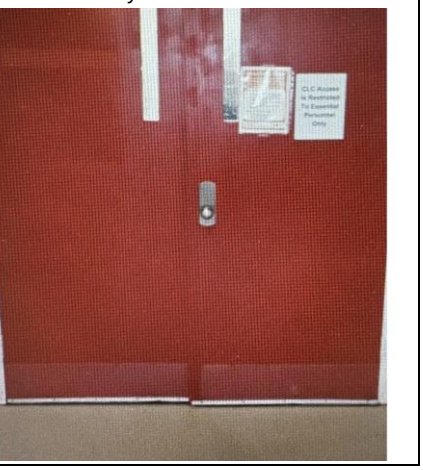
FC10 - Deficiency

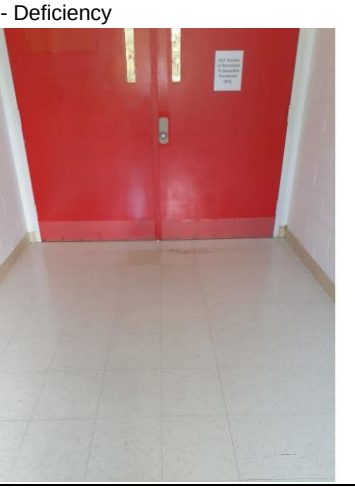
Criteria	Failed Notes	General Notes	Components	Repaired	Compliant Repaired
FC10	Protection plate on door made of combustible material (e.g. masonite, plywood, plexiglass)		Door	No	No

FC10 - Deficiency

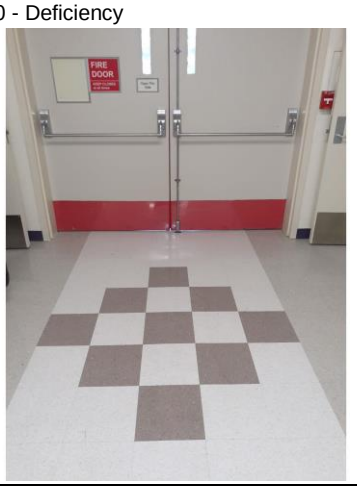
FC10 - Deficiency

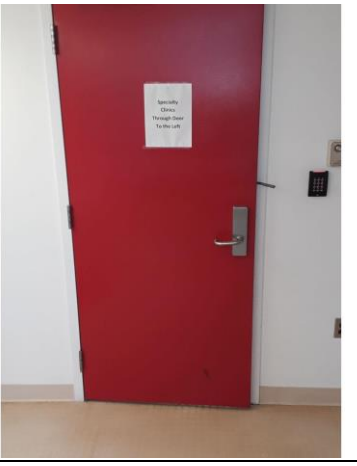
Criteria	Failed Notes	General Notes	Components	Repaired	Compliant Repaired
FC5	Bottom clearance for HM and WD/PLAM > 3/4" HM top edge clearance > 3/16"		Top, Bottom	No	No

FC5 - Deficiency

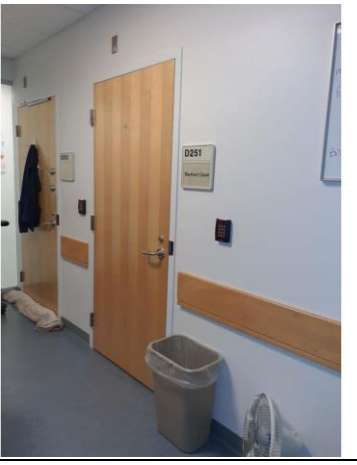
Criteria	Failed Notes	General Notes	Components	Repaired	Compliant Repaired
FC1	Unused fastener hole in frame / door		Door	No	No

FC1 - Deficiency

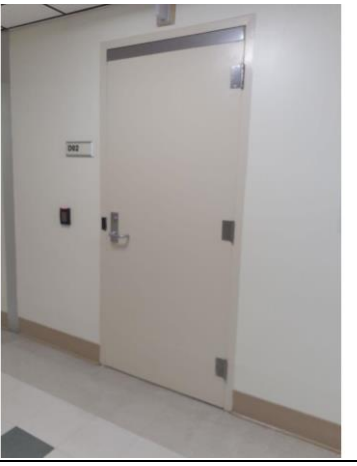
Criteria	Failed Notes	General Notes	Components	Repaired	Compliant Repaired
FC10	Protection plate on door made of combustible material (e.g. masonite, plywood, plexiglass)		Door	No	No

FC10 - Deficiency

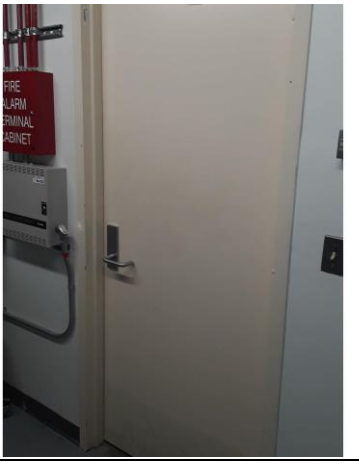
Criteria	Failed Notes	General Notes	Components	Repaired	Compliant Repaired
FC1	Missing silencer / mute		Frame	Yes	Yes

FC1 - Repaired Deficiency

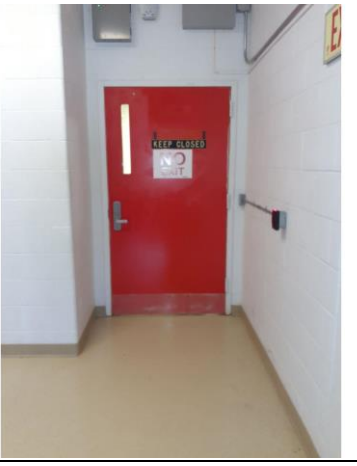
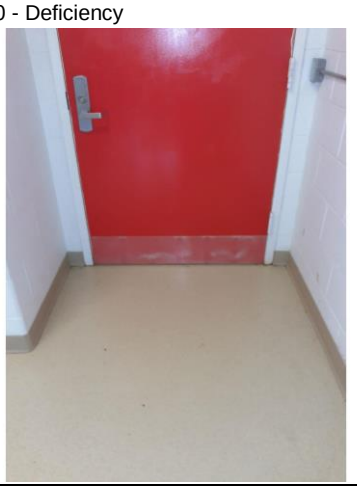
Barcode Door Type	Fire / Smoke Door Material	P/F Door Size	Area Frame Material	Inspector Barrier Type	Date Priority
265-410299-001-0018	Yes / No	Failed	STAIR #2 S2	Ivan Albert	9/06/2024
Single	Hollow Metal	36" x 84"	Hollow Metal Filled	2-Hour Fire Barrier	Immediate

Criteria	Failed Notes	General Notes	Components	Repaired	Compliant Repaired
FC10	Protection plate on door made of combustible material (e.g. masonite, plywood, plexiglass)		Door	No	No

FC10 - Deficiency

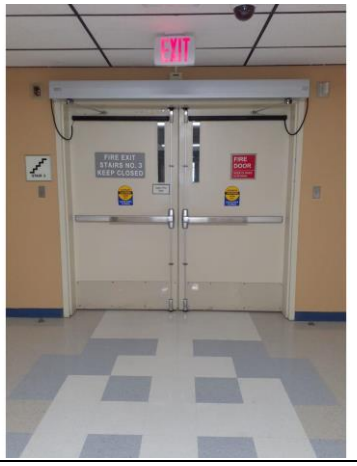
Barcode Door Type	Fire / Smoke Door Material	P/F Door Size	Area Frame Material	Inspector Barrier Type	Date Priority
265-410299-001-0020	Yes / No	Failed	STAIR #3 S3	Ivan Albert	9/06/2024
Pair	Hollow Metal	42" (3'6") x	Hollow Metal Filled	2-Hour Fire Barrier	Immediate

Criteria	Failed Notes	General Notes	Components	Repaired	Compliant Repaired
FC10	Protection plate on door made of combustible material (e.g. masonite, plywood, plexiglass)		Door	No	No

FC10 - Deficiency

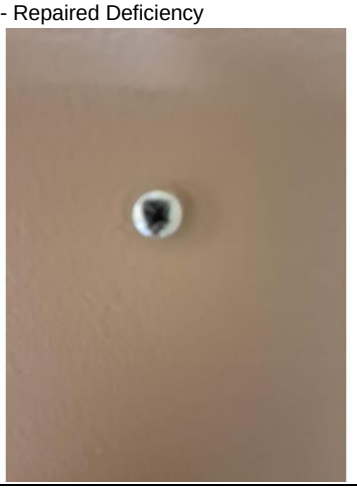
Criteria	Failed Notes	General Notes	Components	Repaired	Compliant Repaired
FC1	Unused hardware leaving hole in the door or frame		Frame	Yes	Yes
FC6	Stack pressure is preventing door closer from operating properly		Hardware	Yes	Yes

FC1 - Repaired Deficiency

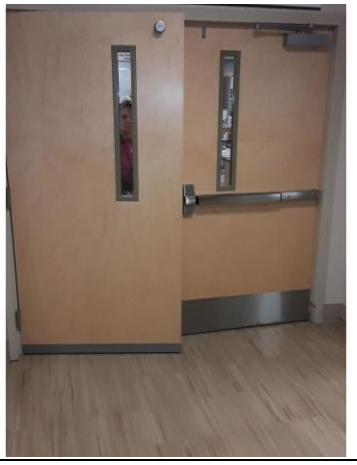
FC6 - Repaired Deficiency

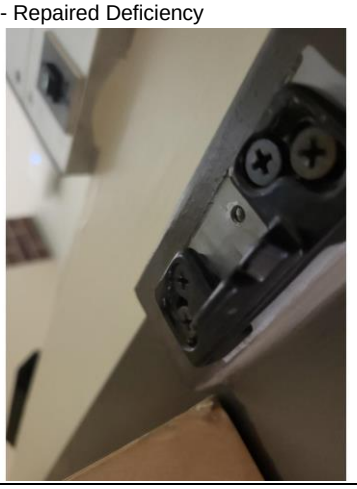
Barcode Door Type	Fire / Smoke Door Material	P/F Door Size	Area Frame Material	Inspector Barrier Type	Date Priority
265-410299-001-0002	Yes / No	Failed	CORRIDOR 103A	Ivan Albert	9/06/2024
Double Egress	Wood	48" x 84"	Hollow Metal Not Filled	2-Hour Fire Barrier	Critical

Criteria	Failed Notes	General Notes	Components	Repaired	Compliant Repaired
FC4	Strike plate missing fastener		Hardware	Yes	Yes
FC6	Sweep or other hardware hindering closing		Hardware	Yes	Yes
FC8	Fire exit hardware missing bottom rod without fire pin		Hardware	No	No

FC4 - Repaired Deficiency

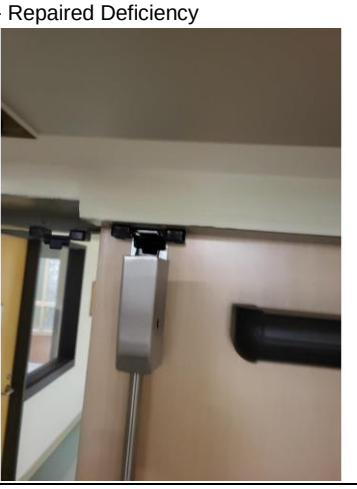
FC6 - Repaired Deficiency
