Pantheon Saloon/Red Front Roofs – **Parapet Caps and Roofing to be removed by NPS**

KLGO 331433A
April, 2026

Exhibit B

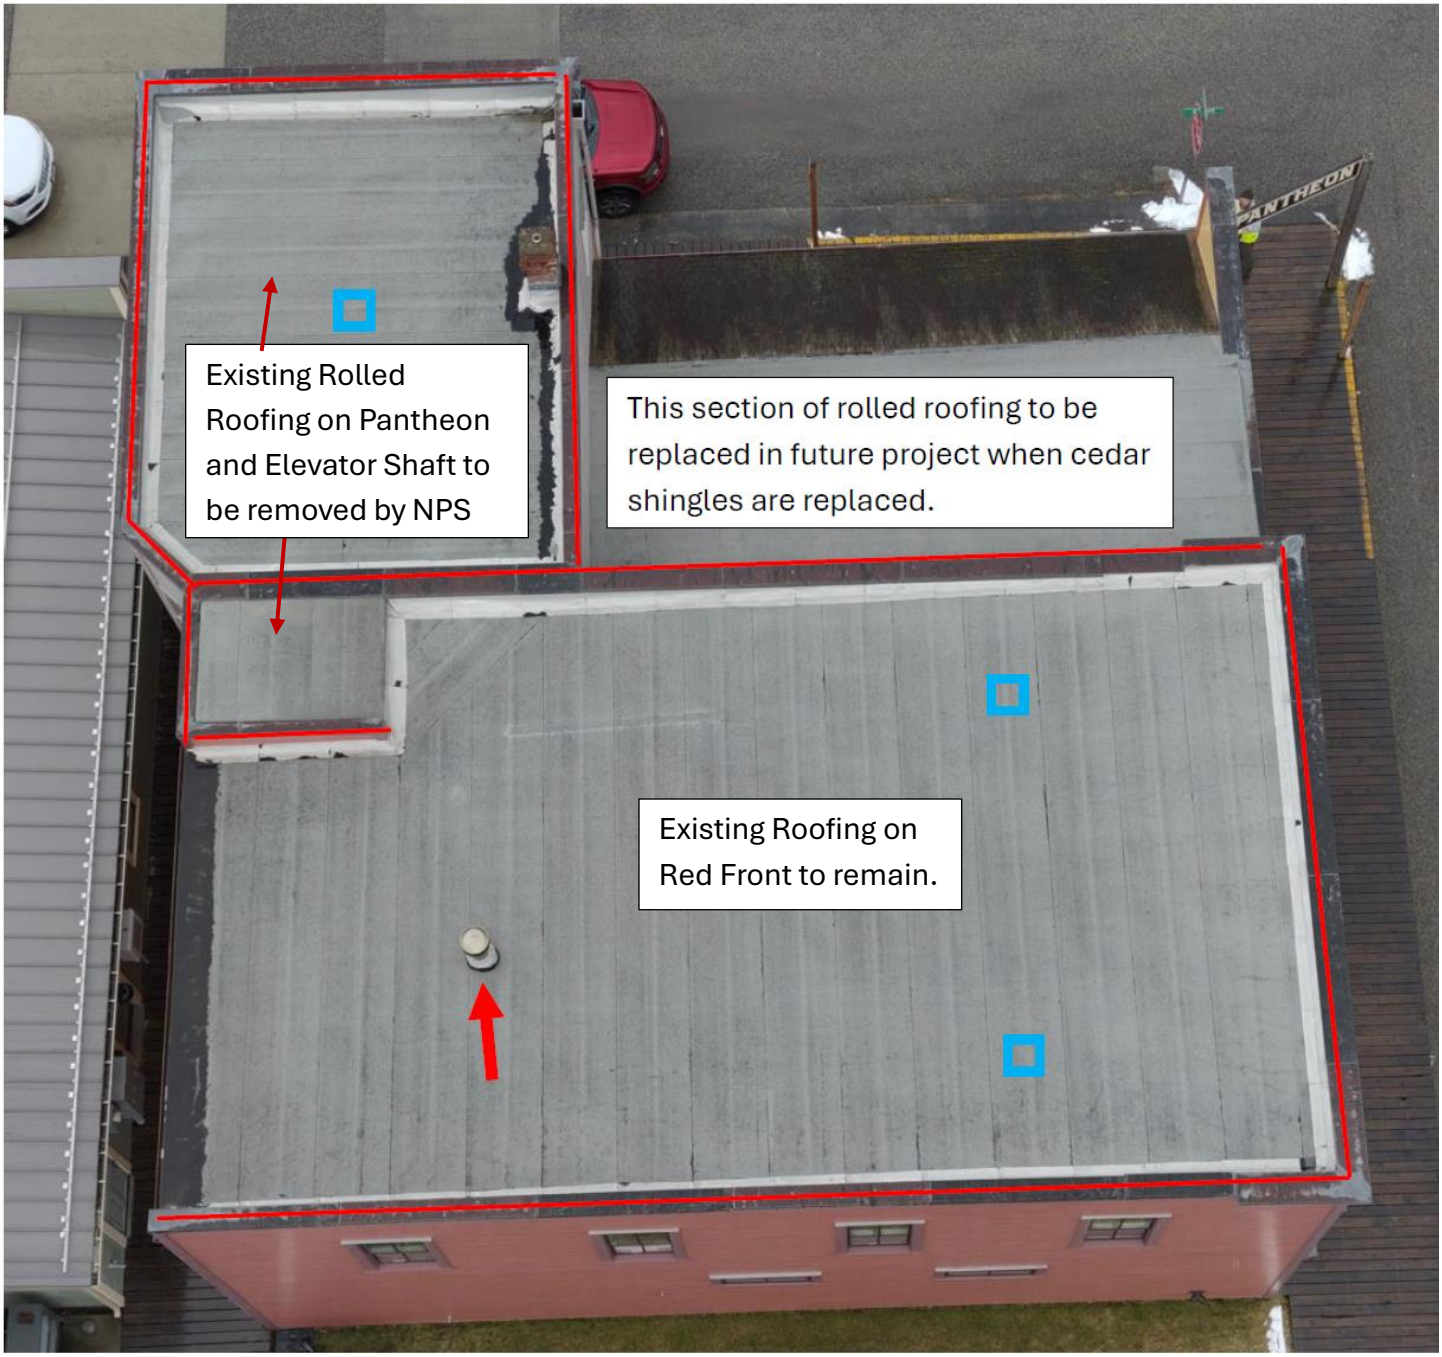
Red lines indicate parapet wall caps to be removed and replaced by NPS Preservation Crew. All grey roofing between the red lines is what will be recovered with new polyvinylchloride (PVC) membrane roofing material. NPS will remove existing rolled roofing on the Pantheon and Elevator Shaft roofs. Existing rolled roofing on the Red Front will remain and be recovered. Chimney (Indicated by large red arrow) on the red front roof is no longer used since the conversion to heat pumps and will be removed by NPS Day labor and the roof penetration recovered with matching sheathing to match existing. Blue Squares are approximate locations of roof fall protection anchors.

Red box indicates area of Pantheon roof known to have sheathing damage from water infiltration caused by the leaking scupper (indicated by the arrow) flashing that was repaired during the 2023 exterior finishes project. On going leak into the workroom during certain weather conditions is near the chimney. The black "Henry's Roof Patching" has been our attempt to mitigate the leak. NPS will remove entirety of existing roofing on Pantheon Roof and repair/replace sheathing and joists necessary prior to contractor arrival.
